## Draft Halite Risk Assessment

852552-WSPE-IA-ES-PD-G4-99283

**HYNET NORTH WEST HYDROGEN PIPELINE PROJECT**

**HALITE RISK ASSESSMENT**

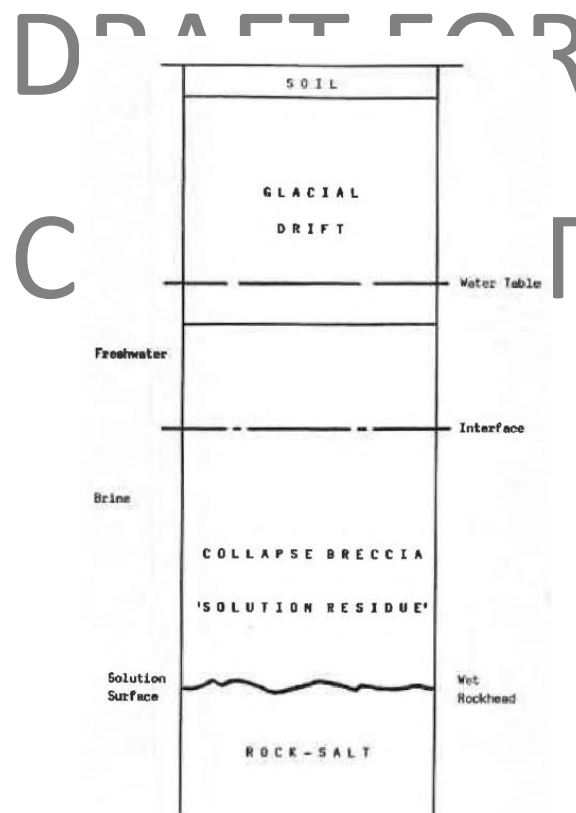
**Figure 4.1: Typical Section through “Wet Rockhead”**

- 4.1 “Wet rock head” exists where salt bearing deposits, namely the Northwich Halite Member (NHM) and the Wilkesley Halite Member (WHM) subcrop beneath the Superficial Deposits. Because salt is readily soluble in water, it typically does not appear at outcrop, at the surface, as an insoluble strata typically would. “A Report on the Rocksalt Mines and Brine Shafts in the Cheshire Saltfield”, dated July 1987 and prepared by Peter Wharmby, a former mineral surveyor of the CBSCB, has been reviewed in the preparation of this risk assessment. “Wharmby” reports that there is no record of rocksalt ever having been found in Cheshire at depths shallower than 40mbgl. As the deposits of salt approach the ground surface, they are eroded by the action of naturally circulating groundwater and terminate in a solution surface some distance below the base of the Superficial Deposits. This scenario is depicted in Figure 4.1 below.

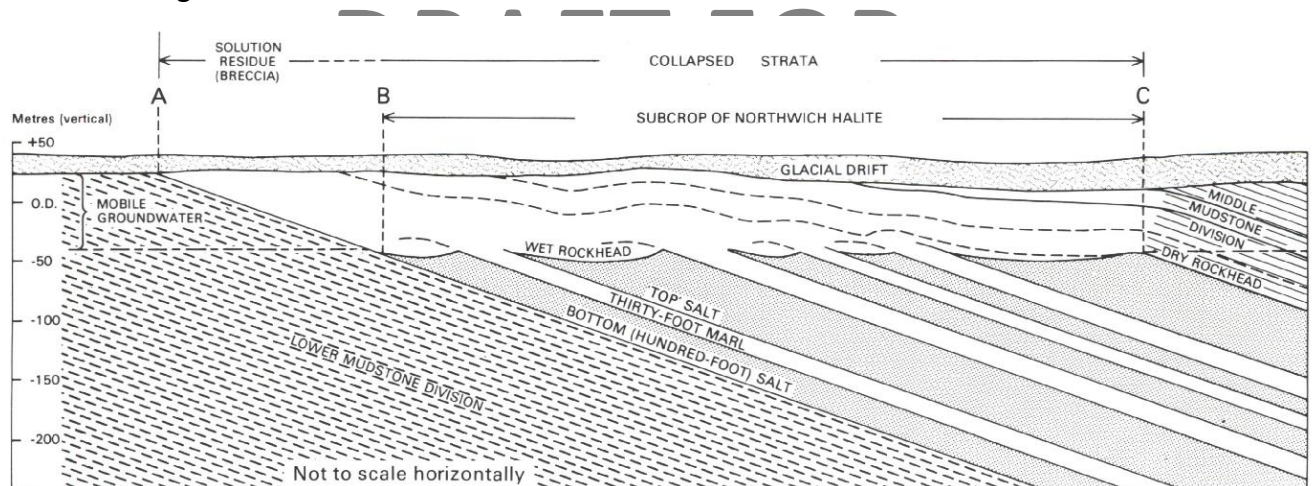
**Figure 4.2: Relationship between “wet and dry rock head”. Source: Wharmby, 1987.**

4.3 Typically, in the Cheshire Saltfield, “wet rockhead” is present where the halite deposits subcrop, and it is in these areas where rock salt deposits have been extensively exploited by brine pumping methods. The solution surface may present itself as an underground stream, which can extend up to 3-5km, and it is these areas where potential zones of intensive dissolution and subsidence can occur. Figure 4.2 illustrates the relationship between “wet and dry rockhead”.

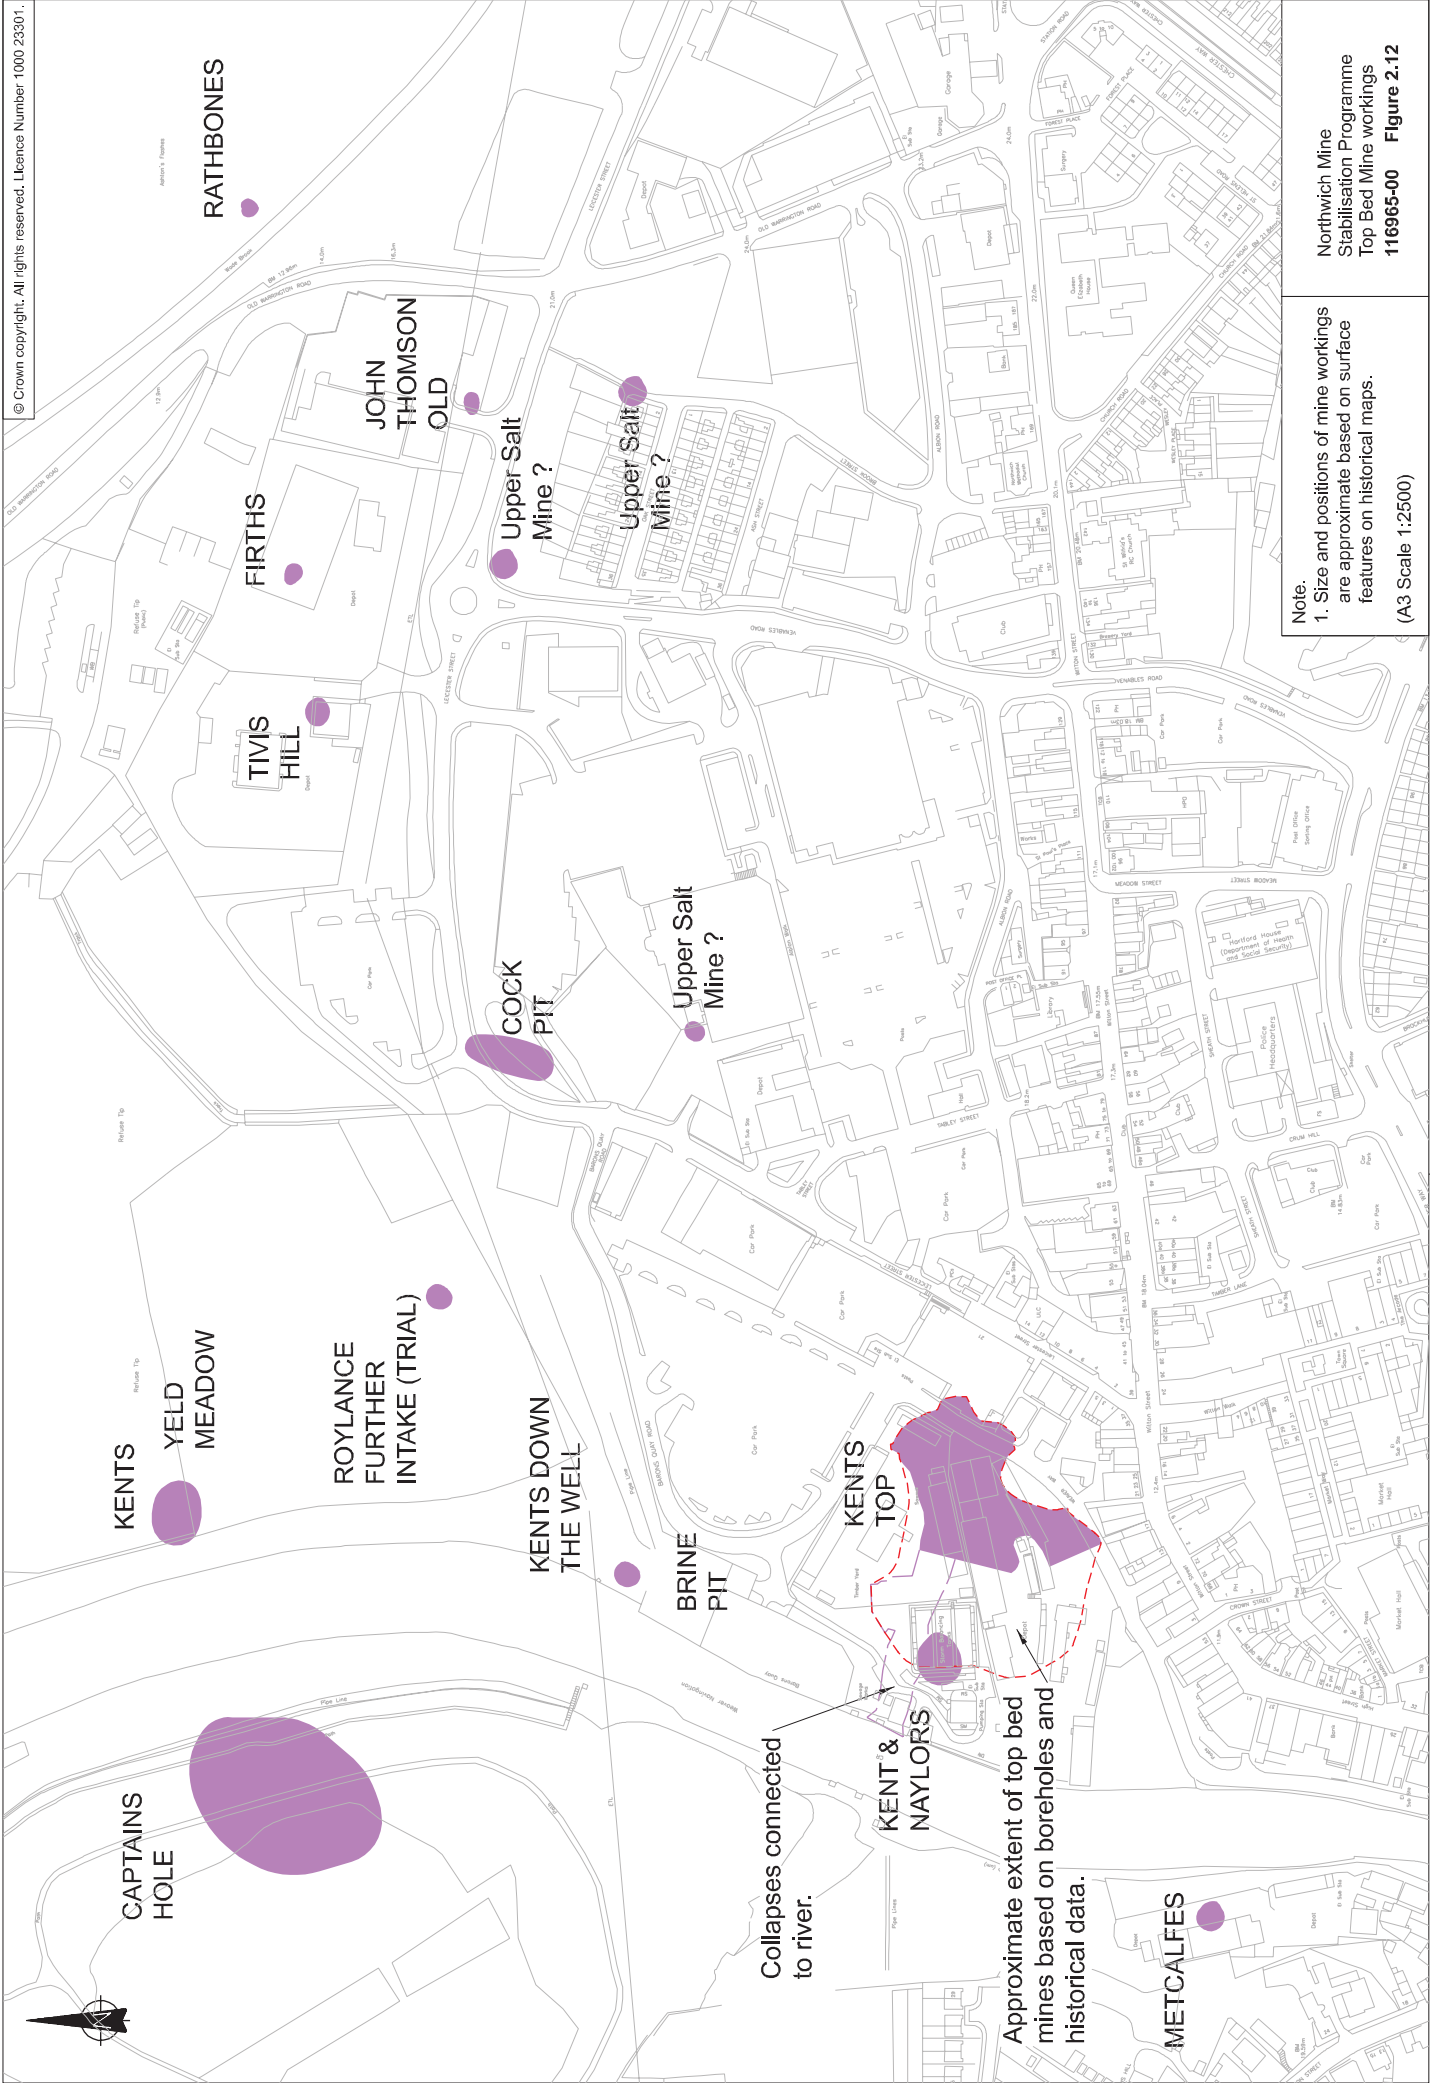
**Northwich Mine Stabilisation Programme Top Bed Workings, reference  
116965, Figure 2.12 obtained from Top Bed Salt Desk Study Report  
prepared by Arup.**

10.9 The Arup report refers to these secondary sources as 18<sup>th</sup> Century surface plans (dated 1721, 1768 and 1797), and refer to mines within the Top Bed. The 1768 plan references the Top Bed mines and brine pits owned by a Sir John Fleming Leicester. The Top Bed mines were considered to be largely unstable in the long term due to poor roof conditions in the immediately overlying “wet rockhead” and high extraction ratios. Therefore, it is considered likely that most of the Top Bed mines consisted of a shaft and a small chamber excavated into the halite.

10.17 Due to the absence of abandoned mine plans of the Top Bed mines, it is possible that the workings detailed above may extend over a greater distance and the possibility of them being present beneath the DOL cannot be wholly discounted. "Wharmby" states that, in the case of the Top Bed mine workings, mining continued until the volume of water or brine entering the shaft became too great and the mine was allowed to flood, or the entry of water caused the shaft to become unsafe or collapse. Considering this information, the CBSCB assume that such unrecorded workings would lie within a 50m radius surrounding the respective shaft.
